# Manhole Inspection Summary

Manhole # S05EE2005MH

**Location** Address: **6214 WOODCREST AVE**

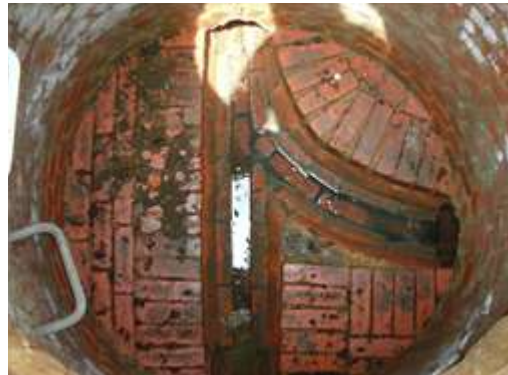
Top View

Corbel and Barrel infiltration. Evidence of surcharge - Bench debris.

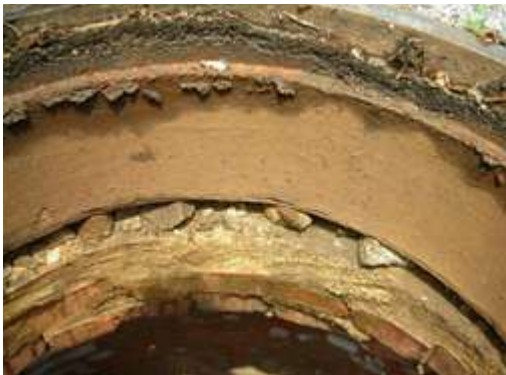
Defect

Frame leaks. Adjustment deterioration and infiltration.

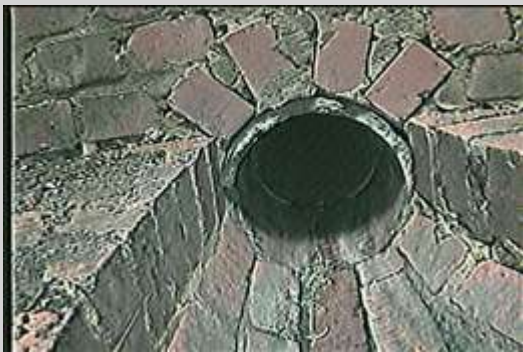
Pipe Out @ 12 O'Clock

Comments **The O12 pipe seal is not flush to the pipe.**

Barrel deterioration and infiltration. Channel deterioration.

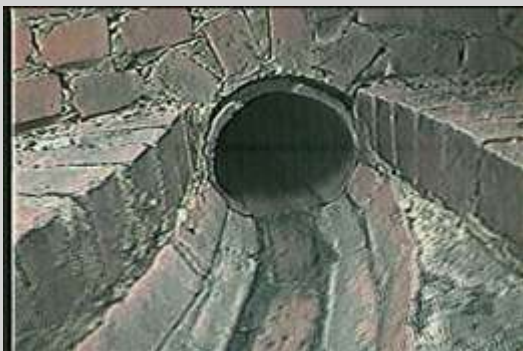
Pipe In @ 3 O'Clock

Infiltration: **Evidence** Pipe Seal Cond: **Broken**

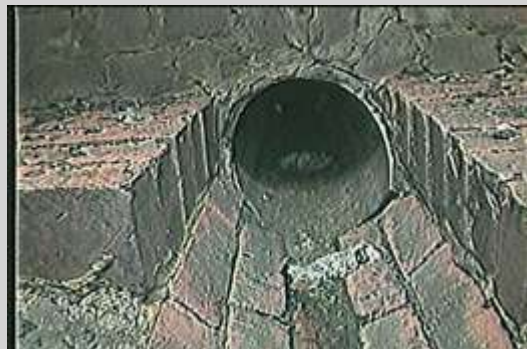
Pipe In @ 6 O'Clock

Deposits: ☐ None ☒ **Mud** ☐ Sludge ☒ **Debris** ☐ Grease

Deposits Extent: **Light**

Infiltration: **Evidence**

Pipe Seal Cond: **Cracked**
